Manhole Inspection Summary

Manhole # S41G__023MH

Location Address: **1127 e lombard st**

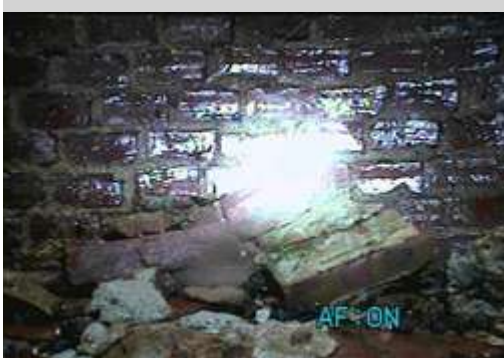
Miscellaneous

bench debris

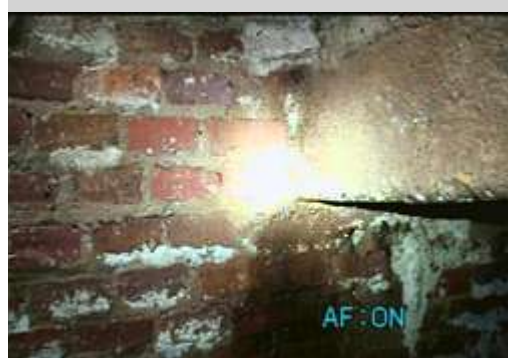
Defect 3

Infiltration: ☐ None ☐ Joint ☐ Cracks ☐ Mortar ☐ Roots ☒ **Wall**

infiltration

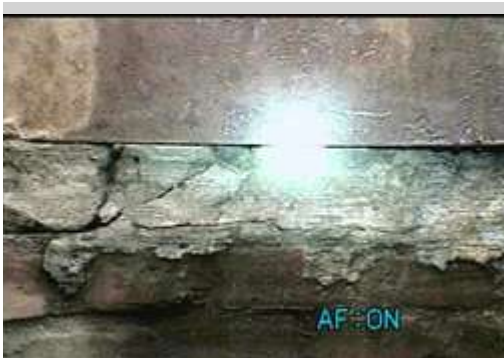
Defect 2

Condition: ☐ Sound ☒ **Cracked** ☐ Root Intrusion ☐ Loose Brick ☐ Deteriorated

frame adj cracked

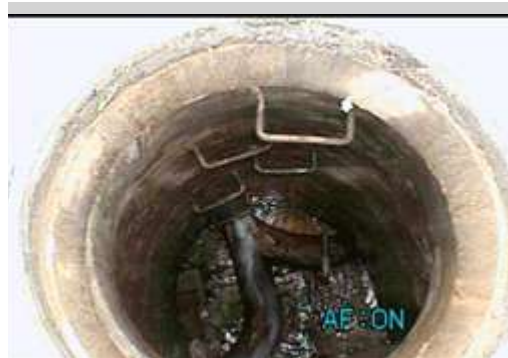
Defect 1

Count: **7** Missing: **1** ☒ **Corroded**

corr steps

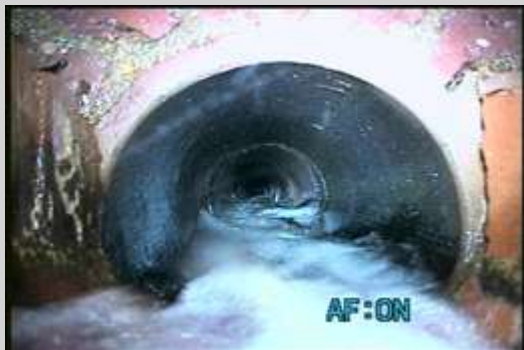
12 O'Clock Outflow

Invert Depth: 6.83 (ft.) Flow Characteristics: Turbulent

Infiltration: None Pipe Seal Cond: Unknown

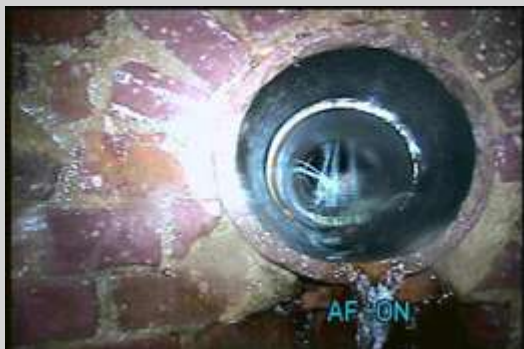
3 O'Clock Inflow

Invert Depth: 8.66 (ft.) Flow Characteristics: Fast

Infiltration: None Pipe Seal Cond: Unknown

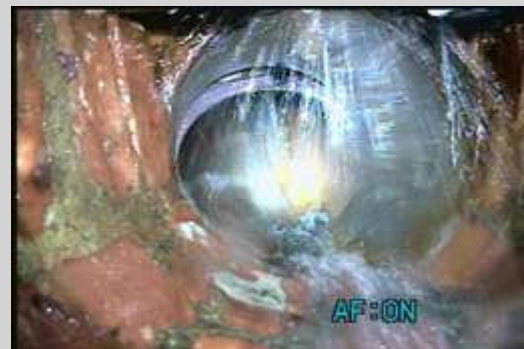
Drop In @ 3 OClock

Drop: Outside Direct

Drop Condition: Open

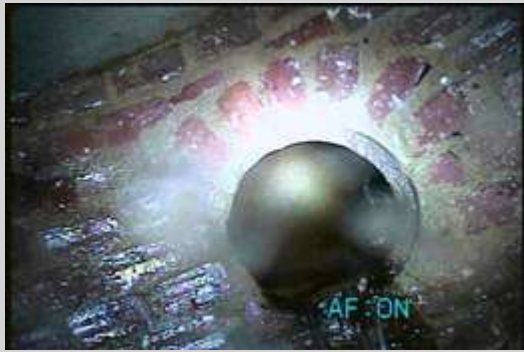
7 O'Clock Inflow

best shot do to angle

Invert Depth: **10.41** (ft.) Flow Characteristics: **Fast**

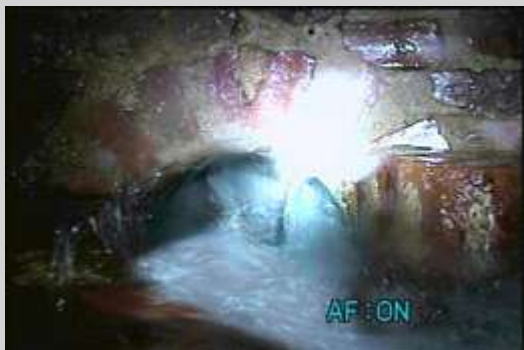
8 O'Clock Inflow

best shot do to turbulent water flow

Invert Depth: **10.46** (ft.) Flow Characteristics: **Turbulent**
